BUTTE-SILVER BOW COUNTY

Traffic Safety Improvement Plan

August, 1990

CLETE DAILY AND ASSOCIATES
TRAFFIC & TRANSPORTATION ENGINEERS
524 W. Lawrence • P.O. Box 223
Helena, Montana 59624

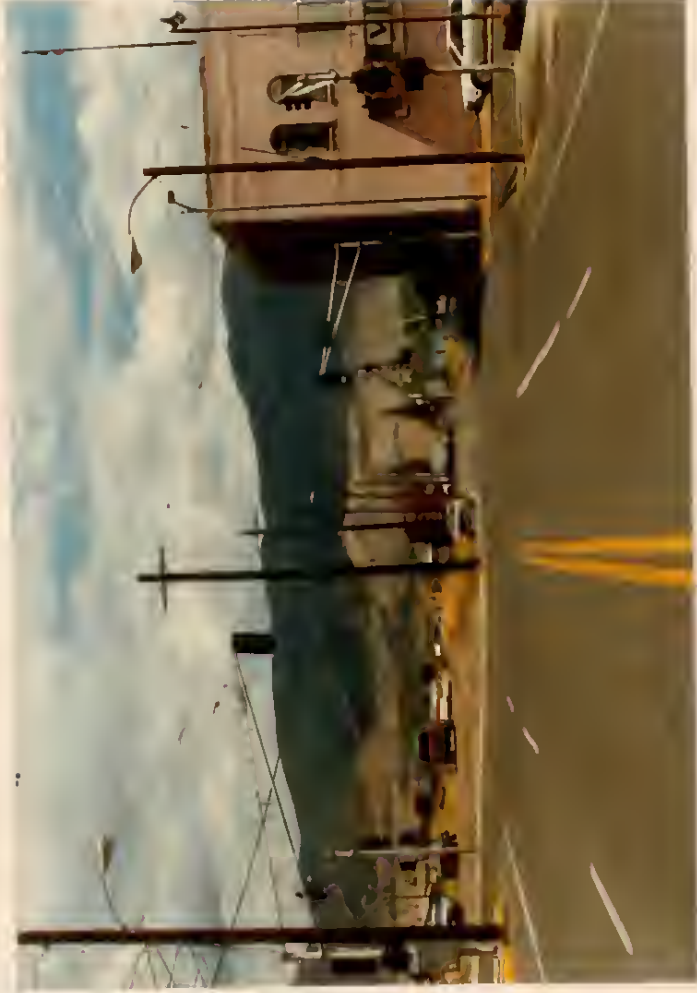
Site No. 1: Arizona and Mercury. West leg of the intersection of Arizona and Mercury looking east. *Note:* two-lane transition on east leg, limited sight distance from east leg south and utility poles in R.O.W.

1. The high incidence of failure to yield accidents indicates a visibility problem, especially for southbound vehicles on Arizona.
2. Eighty-seven percent of the accidents occurred during the daytime with forty percent occurring during the afternoon peak. This indicates a daytime visibility problem.
3. The isolated nature of this signal results in a low degree of driver expectation.
4. Road conditions were not determined to be a major accident cause.

- 1. Replace 8" lens on red indication with 12" lens on all approaches — 8 lenses @ \$150 each\$1200.
- 2. Install 4—36" x 36", W3-3, signal ahead signs 150 feet in advance of the north, south, east and west approaches ..\$560.
- 3. Install 12" x 18", R1-7L, "No Parking Here to Corner" signs on all approaches and paint curbs as shown on Figure 11.\$400
- Total Cost\$2160

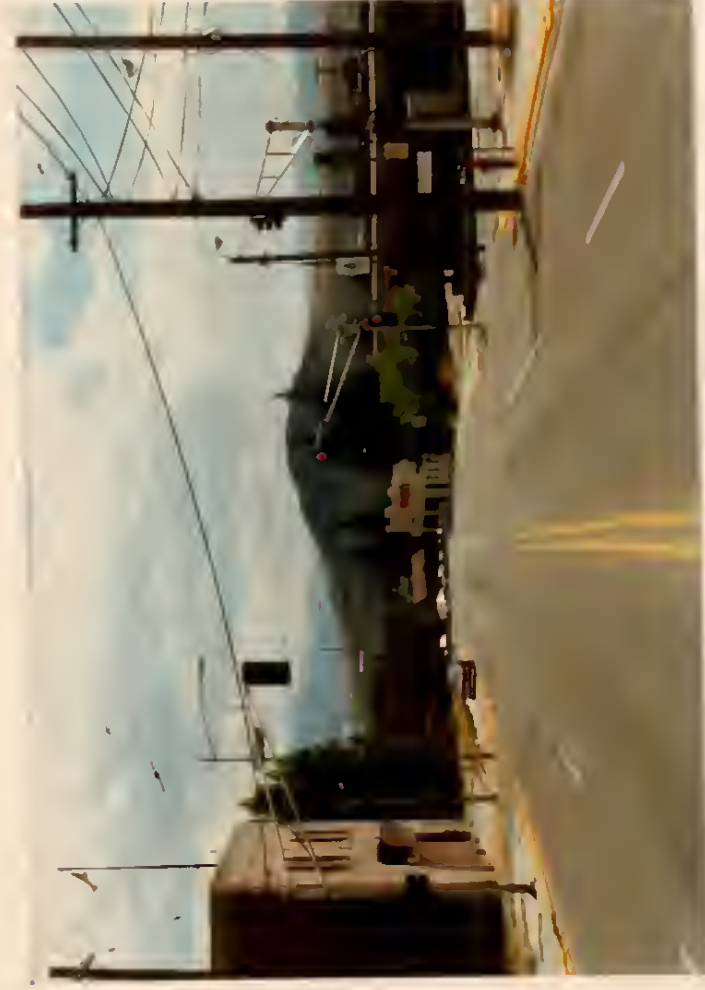
Site No. 1: Arizona and Mercury. North leg of the intersection of Arizona and Mercury looking south. *Note:* utility poles in R.O.W. and downhill grade from north to south.

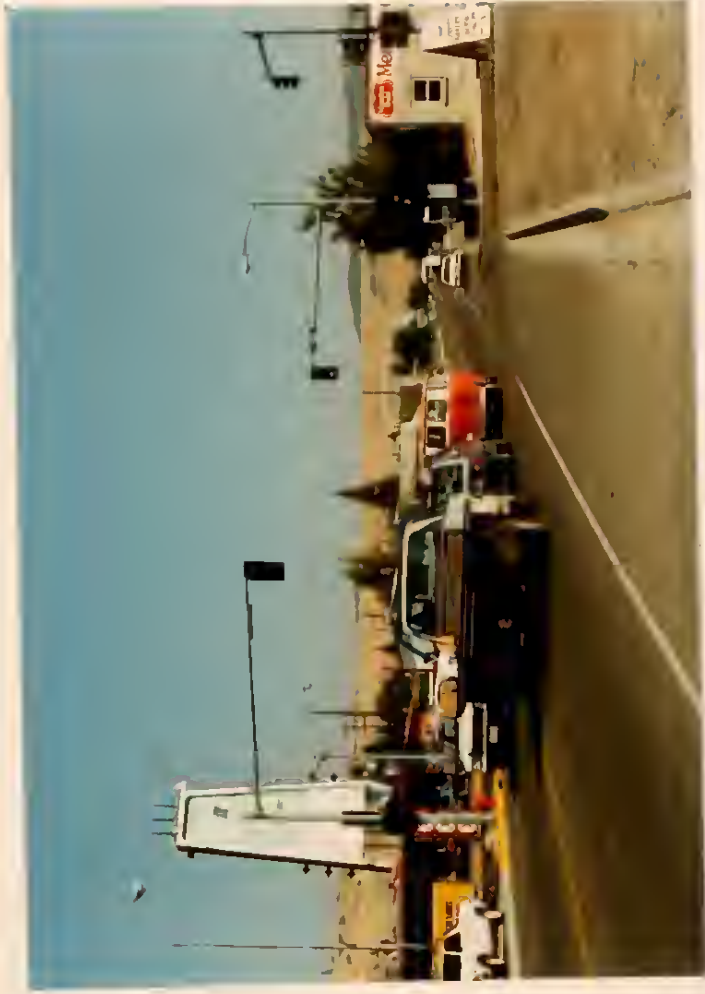
Site No. 2: Farragut and Cobbin. South leg of the intersection of Farragut and Cobbin looking north.

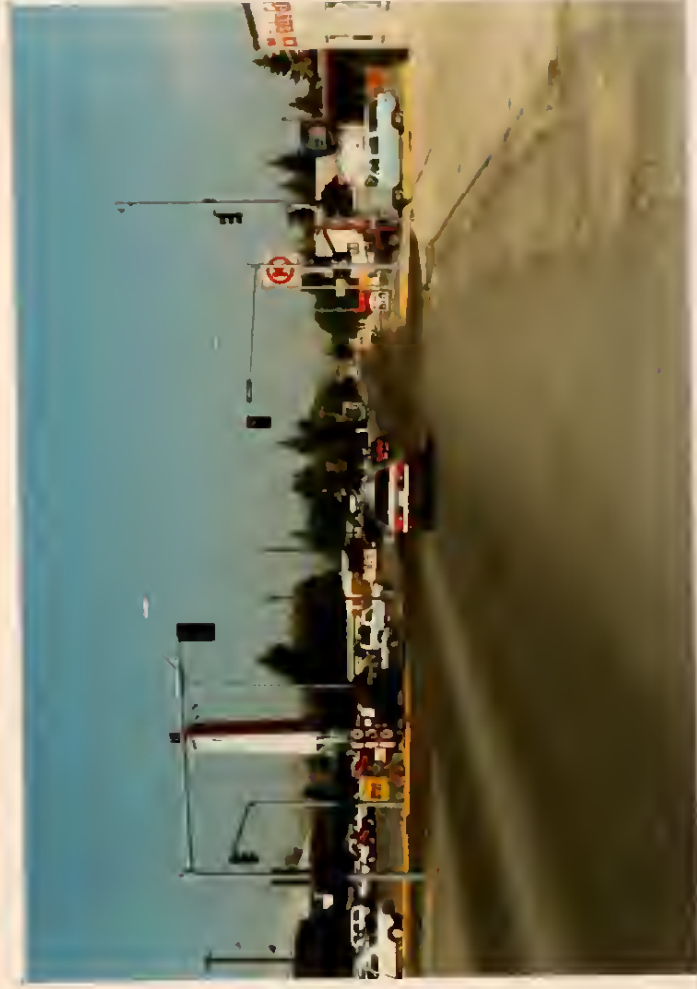
Site No. 2: Farragut and Cobbin. East leg of the intersection of Farragut and Cobbin looking west. *Note:* curb cuts.

1. The major cause of accidents at this site is vehicles running the red signal indication. This is typical of other isolated signals on Farragut. Corrective measures are: increasing signal visibility and providing information in advance of the intersection.

1. Replace 8" lens on red indication with 12" lens on all approaches. \$1200

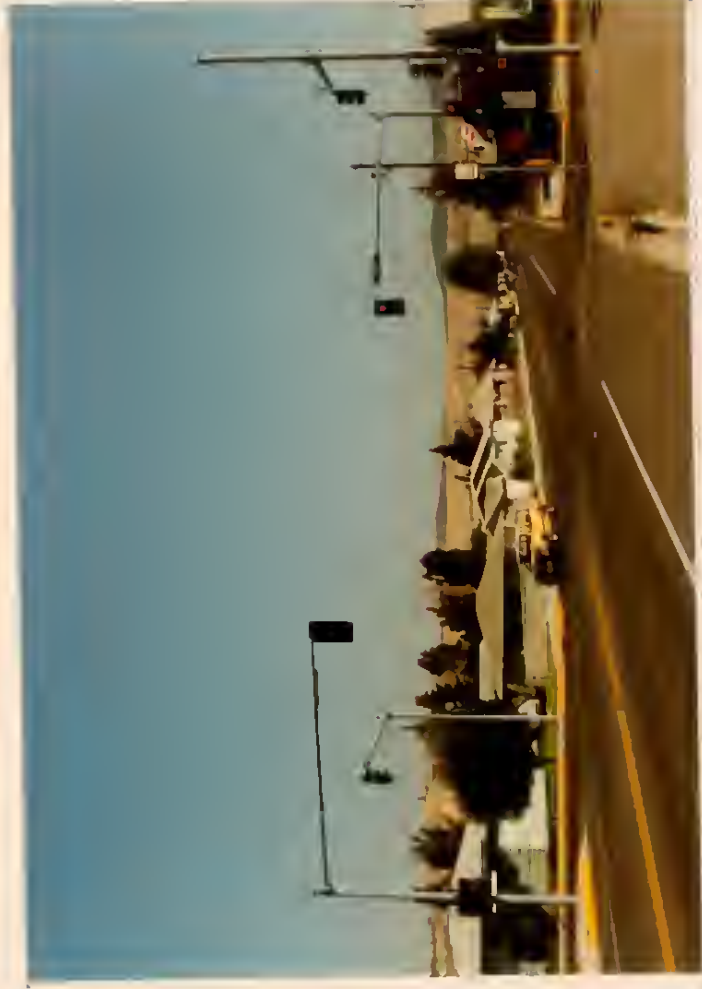
Site No. 3.: Farragut and Amherst. South leg of the intersection of Farragut and Amherst looking north.

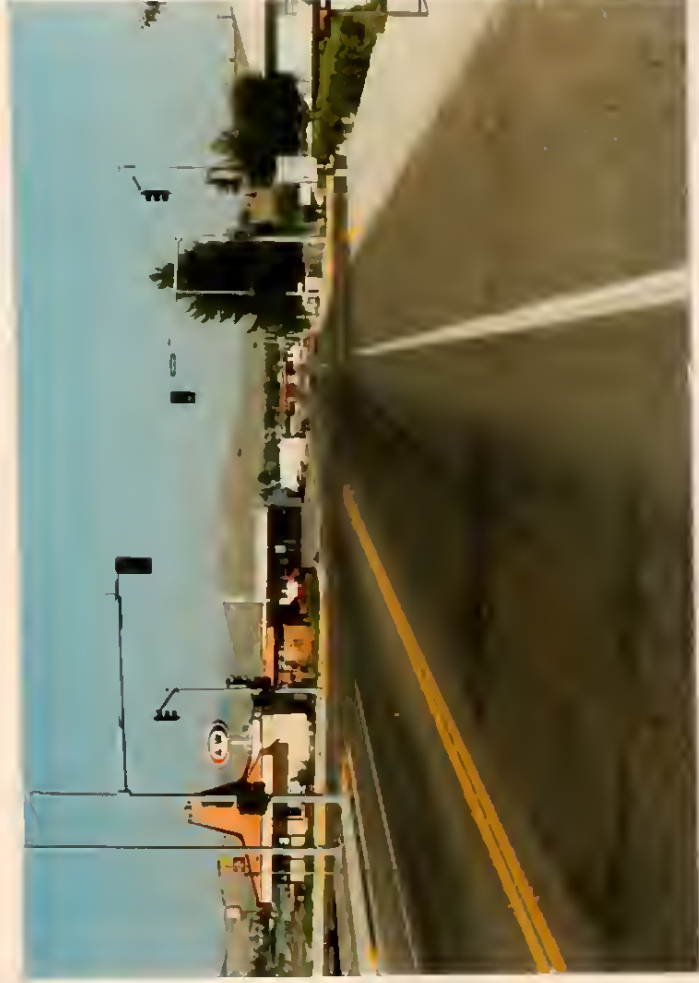
Site No. 3.: Farragut and Amherst. East leg of the intersection of Farragut and Amherst looking west. *Note:* A and W on southwest corner, a heavy traffic generator.

1. Detailed analysis of the officer's reports showed that the following reasons were stated by some of the drivers involved:
 - sun glare obscuring signal indication
 - icy conditions (4 accidents)
 - traffic signal out-of-order
 - traffic signal in flashing mode
 - both drivers claimed signal was green
2. Most accidents occurred during daylight hours indicating daylight visibility may be a problem.
3. The intersection is an isolated signal with the nearest signal located on Harrison Avenue, two blocks away.

- 1. Replace 8" lens or red indication with 12" lens on all approaches — 8 lenses @ \$150\$1200
- 2. Install 4— 36" x 36", W3-3, signal ahead signs, 150 ft. in advance of the north, south, east and west approaches. ..\$560
- 3. Install 12" x 18", R7-1L, "No Parking Here to Corner" signs on all approaches and paint curbs as shown in *Figure 11*. (Note: install 30' in advance of curb cuts at intersection.)\$400
- Total Cost\$2160

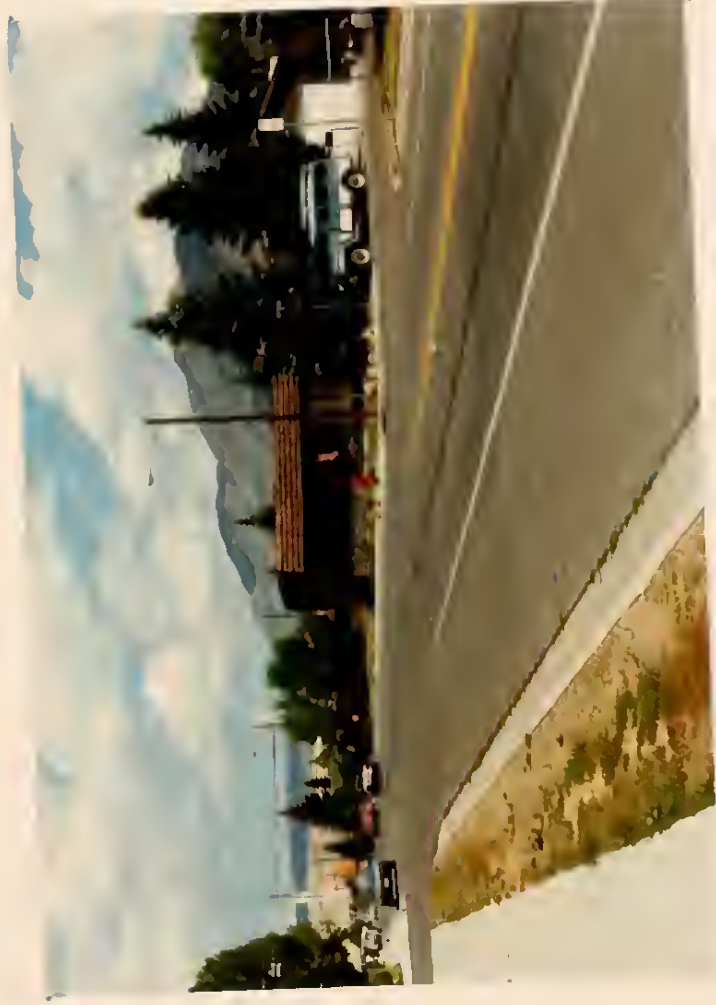
Site No. 7: Farragut and Ottawa. South leg of the intersection of Farragut and Ottawa looking north. *Note:* limited sight distance on northeast and northwest legs.

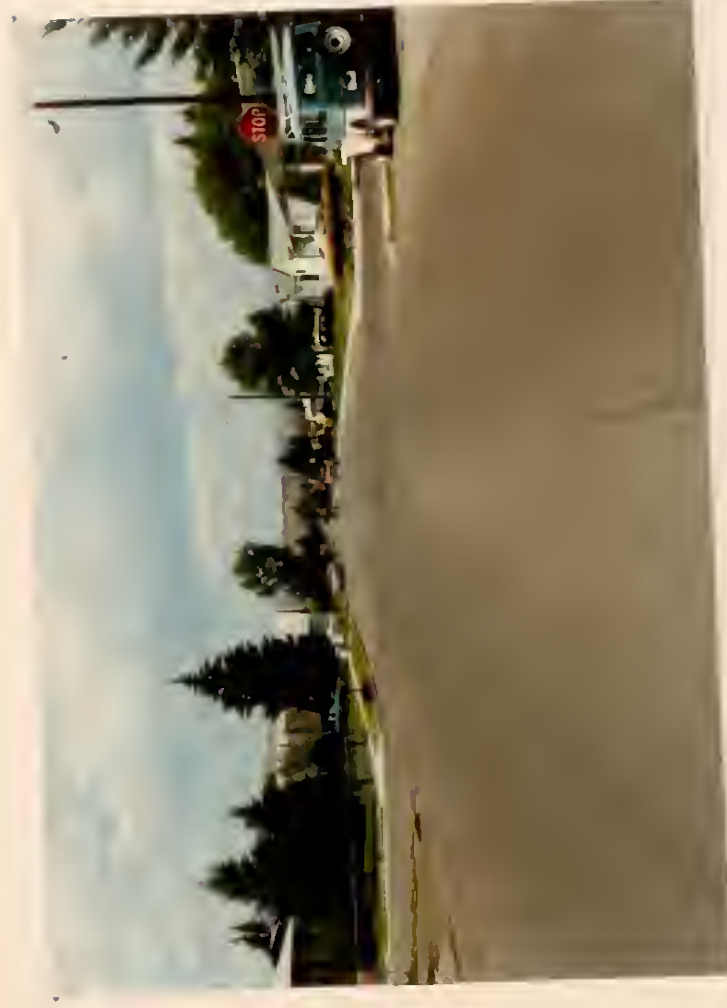
Site No. 7: Farragut and Ottawa. East leg of the intersection of Farragut and Ottawa looking west. *Note:* limited sight distance on northeast leg.

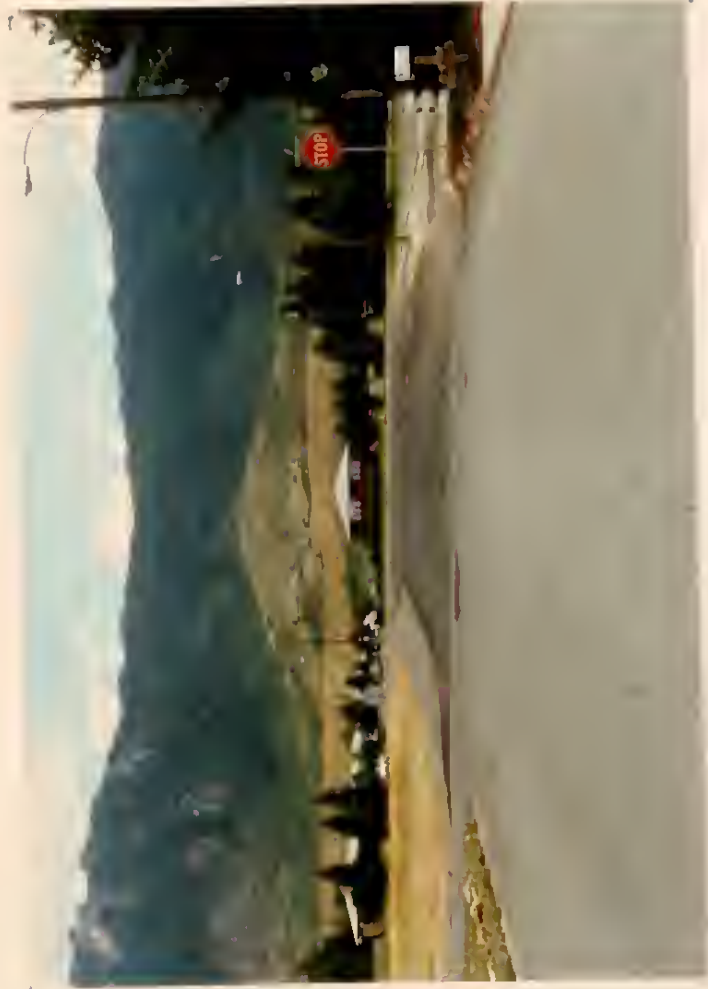
Site No. 8: Continental Drive and St. Anns. West leg of the intersection of Continental Drive and St. Anns looking east. *Note:* limited sight distance on the southwest corner.

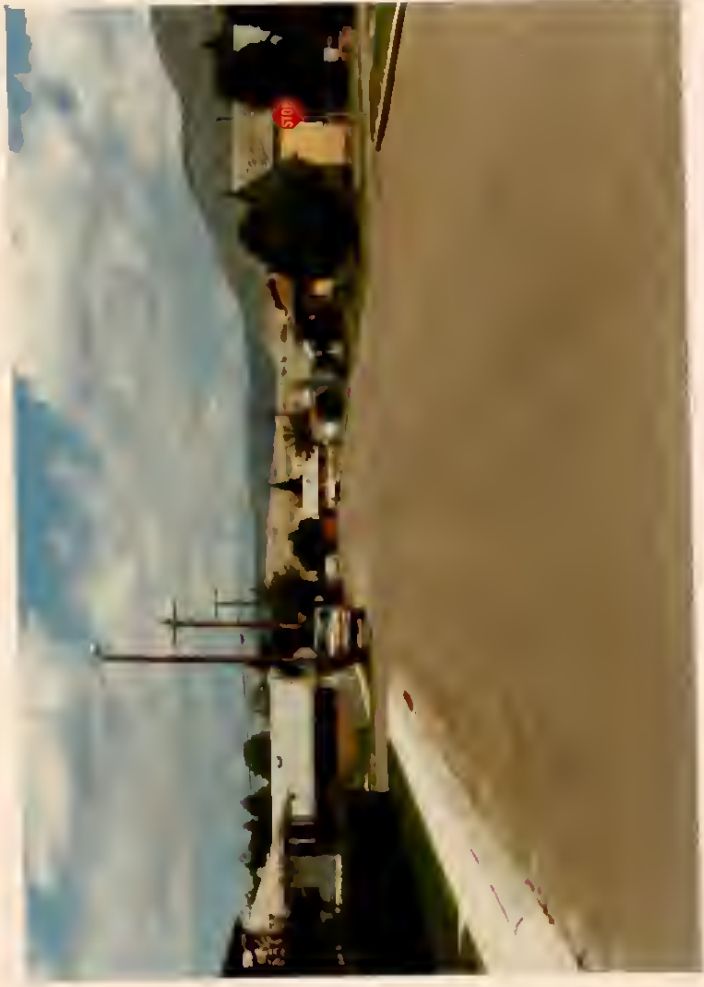
Site No. 9: Thomas and Moulton. South leg of the intersection of Thomas and Moulton looking north. *Note:* limited sight distance on the southwest and northwest corners.

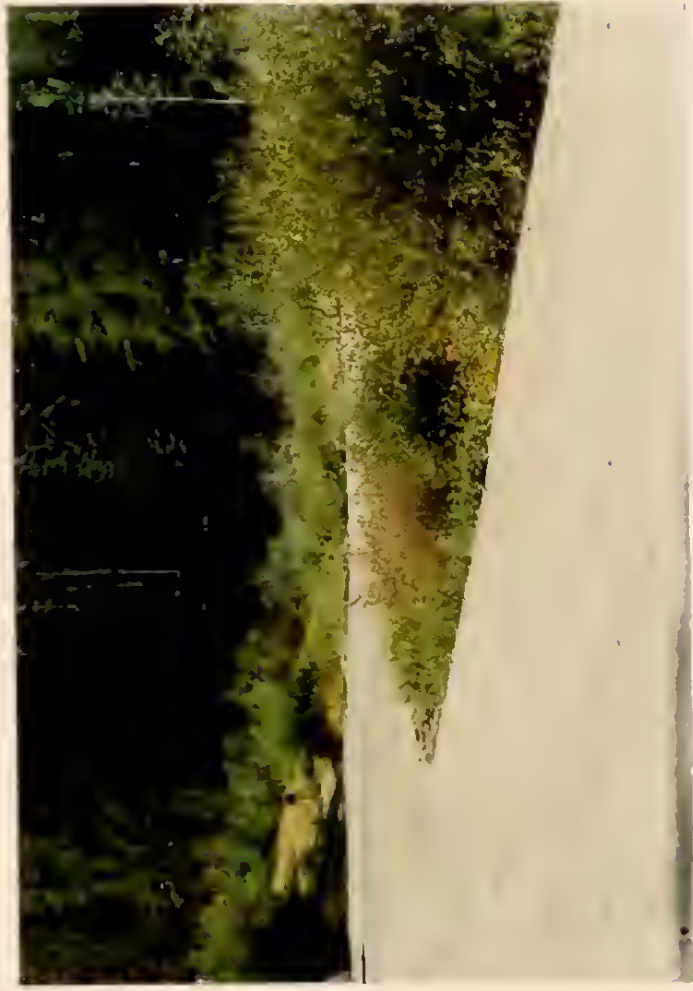
Site No. 10: Roosevelt Drive — curve. North approach of curve on Roosevelt Drive looking south. *Note:* brush on inside of curve.

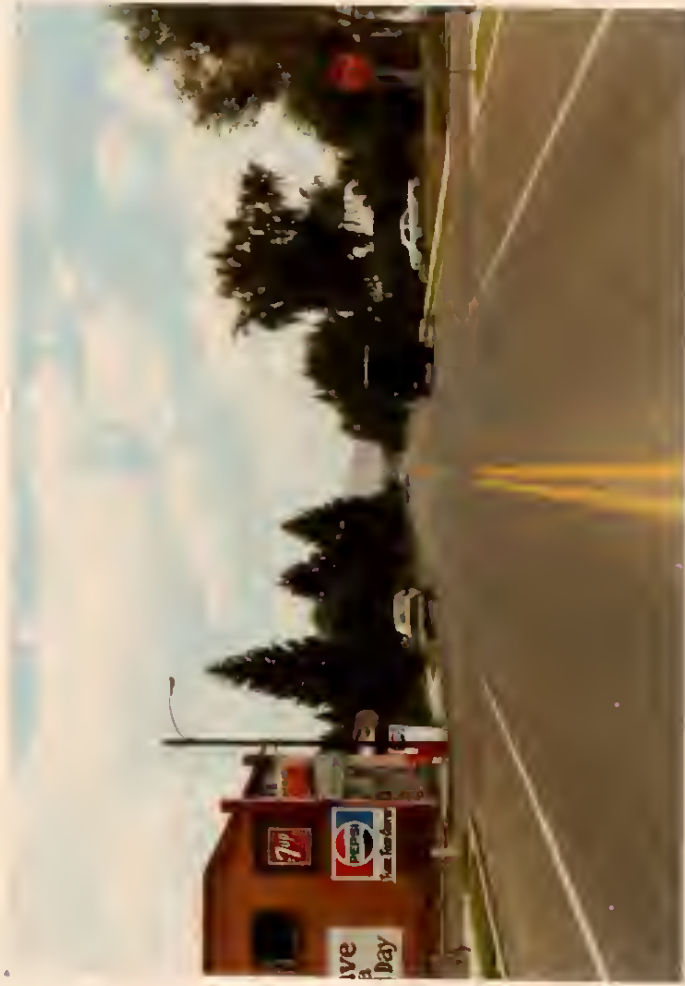
Site No. 13: **Floral and Sheridan.** East leg of the intersection of Sheridan and Floral looking west. *Note:* limited sight distance from west leg looking south.

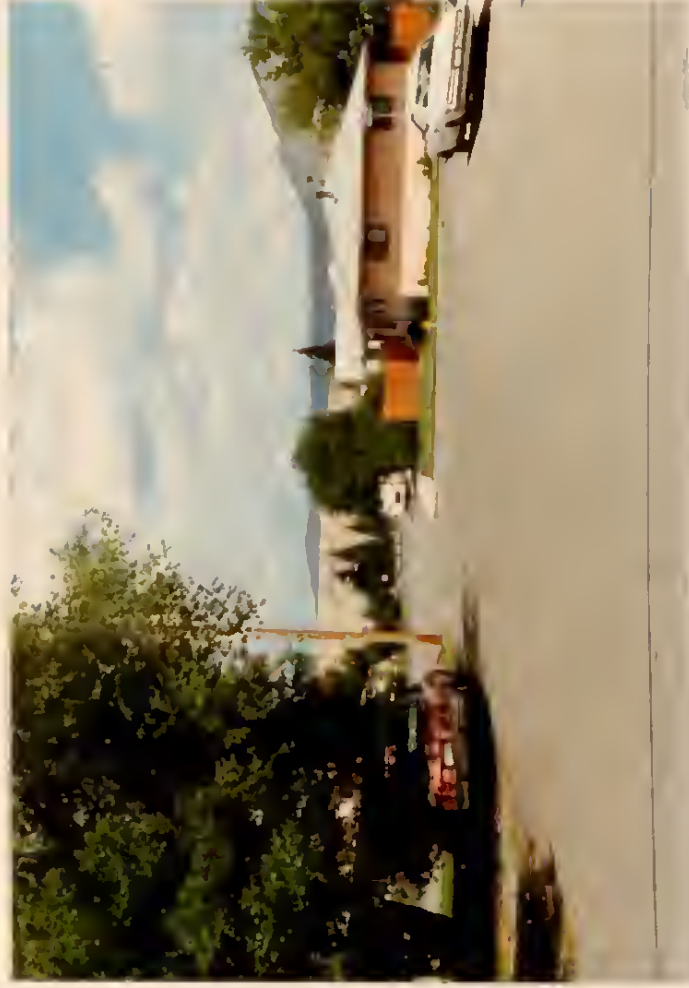
Site No. 14: Thomas and Kossuth. South leg of the intersection of Thomas and Kossuth looking north. *Note:* offset north leg and limited sight distance from south leg west.

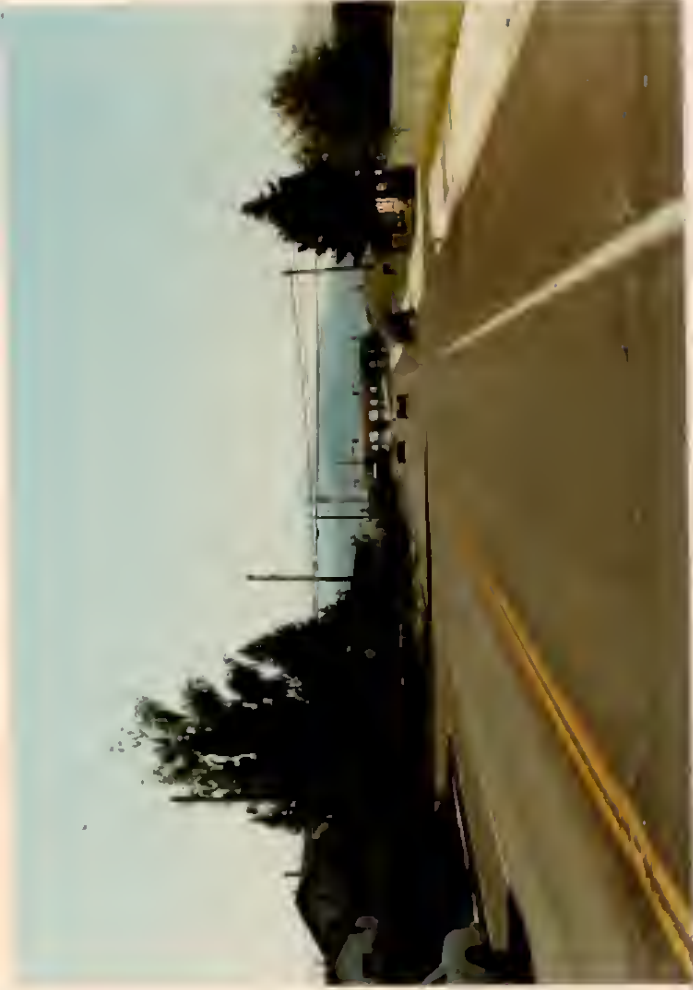
Site No. 16: Farragut and Yale. North leg of the intersection of Farragut and Yale looking south. *Note:* sight distance obstructions on east approach.

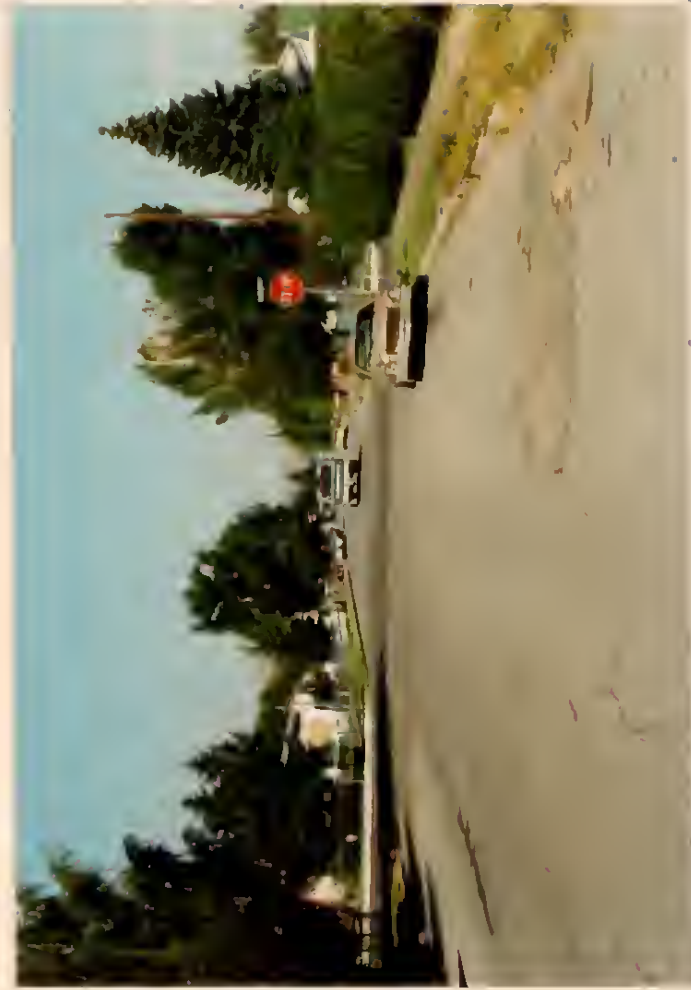
Site No. 16: Farragut and Yale. East leg of the intersection of Farragut and Yale looking west. *Note:* sight distance obstruction on northeast corner.

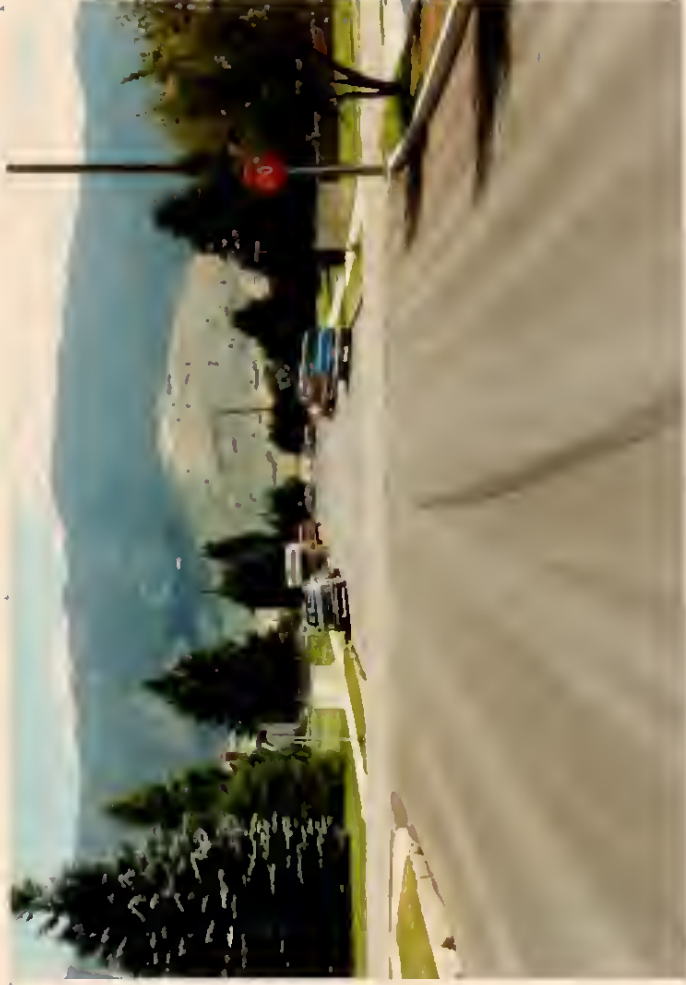
Site No. 17: Sherman and Bayard. West leg of the intersection of Sherman and Bayard looking east. *Note:* foliage screening STOP sign and skid marks.

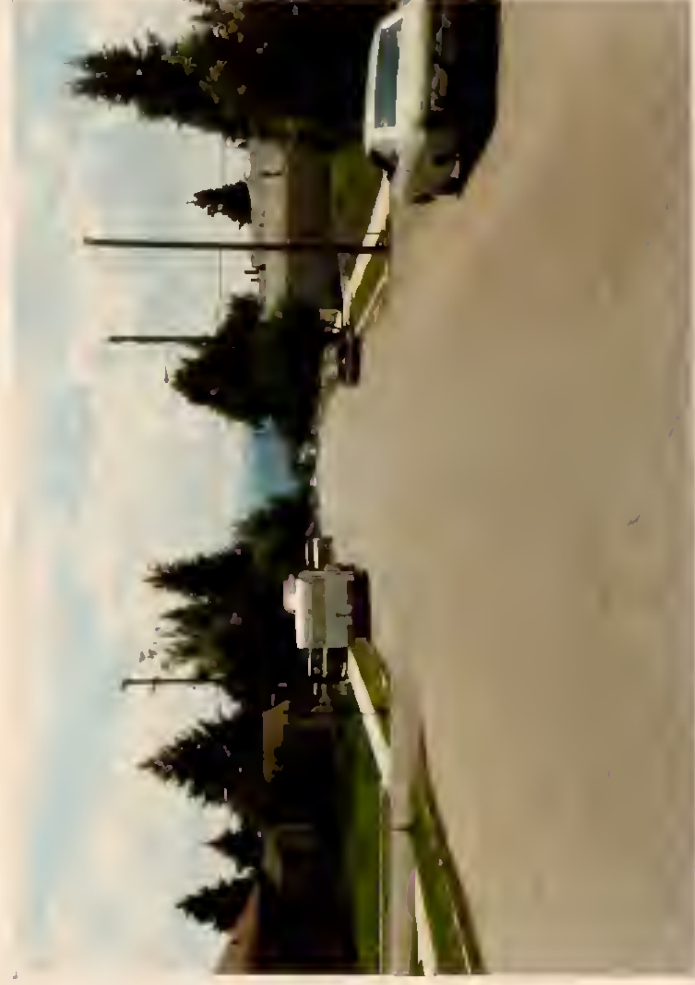
Site No. 17: Sherman and Bayard. North leg of the intersection of Sherman and Bayard looking south. *Note:* limited sight distance on northwest corner.
